RIPARIAN AREA MANAGEMENT

TR 1737-9 1993

Process for Assessing Proper Functioning Condition

Bureau of Land Management

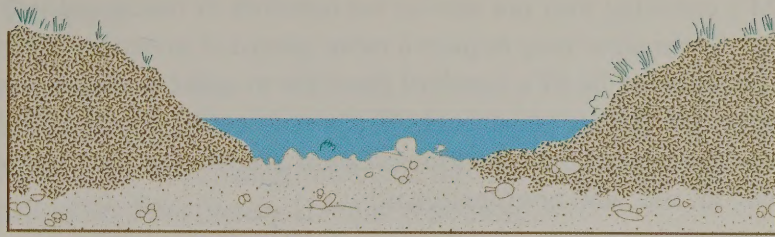
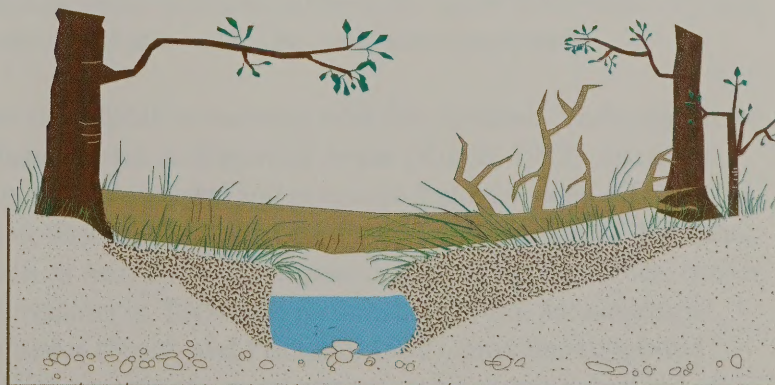
Figure 3. Stream cross sections.

Figures 2 and 3 provide an example of the relationship between PFC and vegetation community succession for one area. Assuming succession continues uninterrupted (Step 1 to Step 2 in Figure 2), the channel will evolve through some predictable changes from bare ground to PNC (although not necessarily as linearly as depicted). The riparian-wetland area will progress through phases of not functioning, functioning—at risk, and properly functioning along with plant succession. In this example, PFC occurs at the mid-seral stage (Step 3). Figure 3 shows a stream cross section of each condition (A-E) displayed in Figure 2.

A
Bare Ground

B
Early Seral

C
Mid-Seral

D
Late Seral

E
PNC or PPC

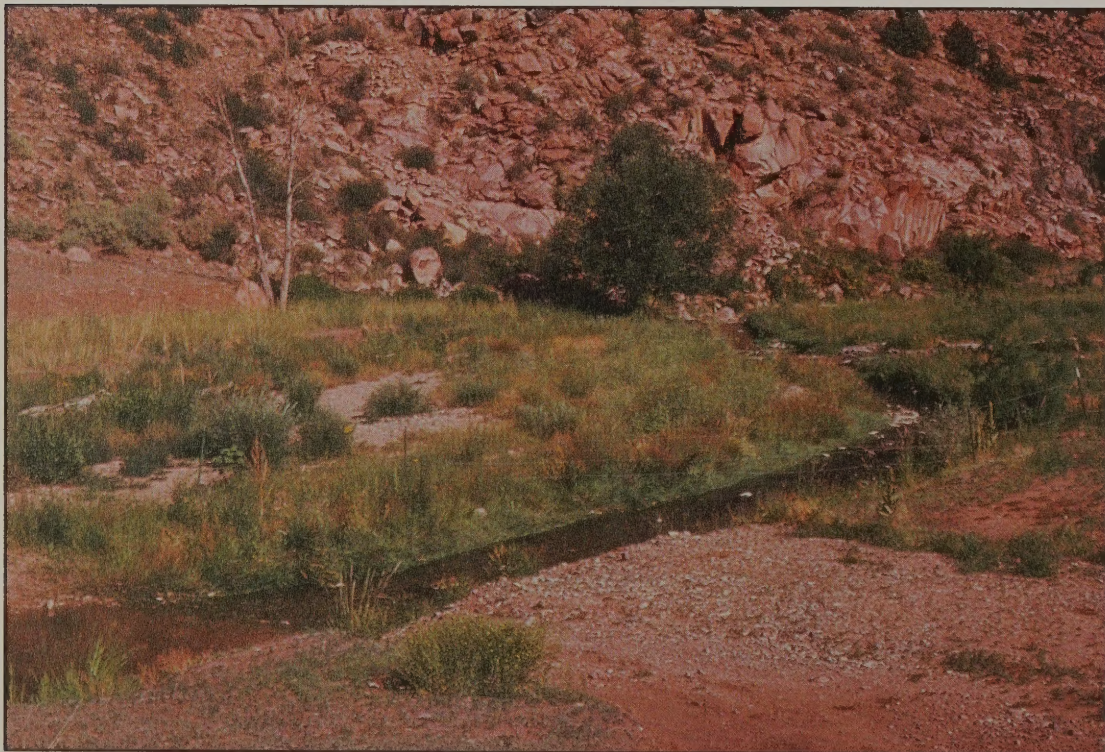
Texas Creek—Colorado
June 1978
Functional—At Risk

Yet, the area was still at risk because soil and vegetation attributes still made it susceptible to degradation. The area contained too much bare soil and lacked desirable species of vegetation. The dominant species present lacked root masses that stabilize streambanks against cutting action.

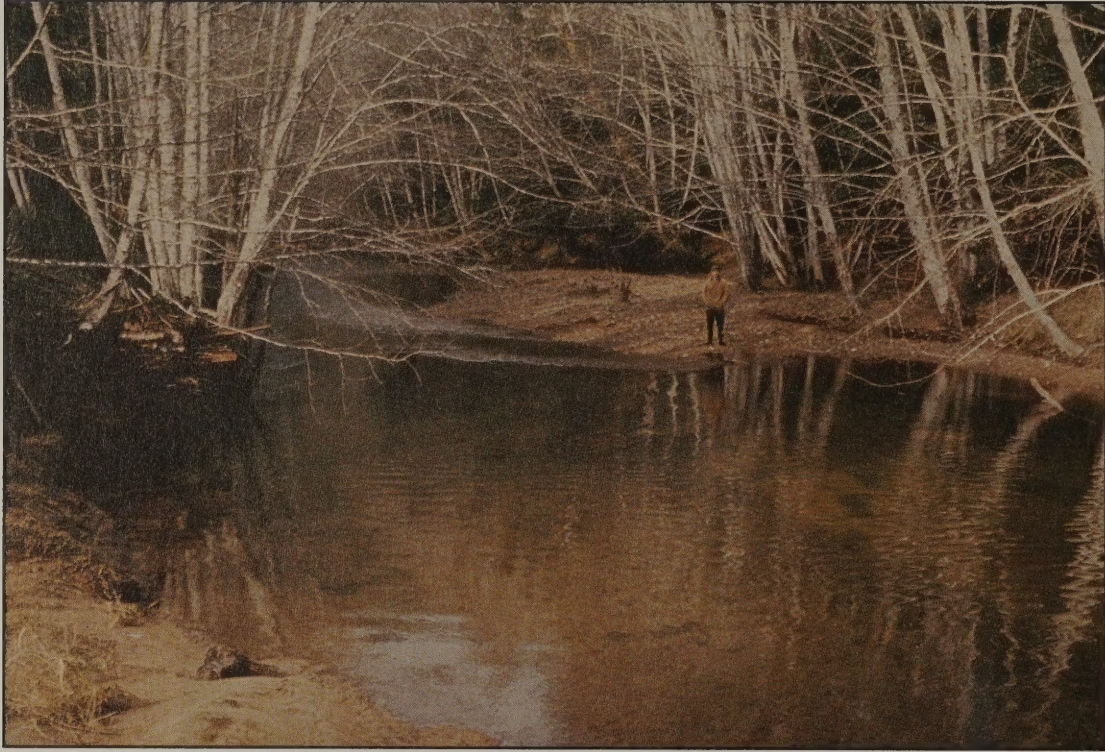
**Forested Coastal Stream—Oregon
Functional—At Risk**

In spite of functioning, this area would be rated as *functional—at risk* because a vegetation and hydrologic attribute still make the area susceptible to degradation. While the alder plant community does provide root masses that stabilize streambanks against cutting action, it probably is insufficient for major flow events. Large woody debris (hydrologic controls) is also lacking, which inhibits capture of sufficient bedload to aid in the development of habitat that provides water depth, duration, and temperature necessary for fish production, waterfowl breeding, and other uses, thus supporting greater biodiversity.

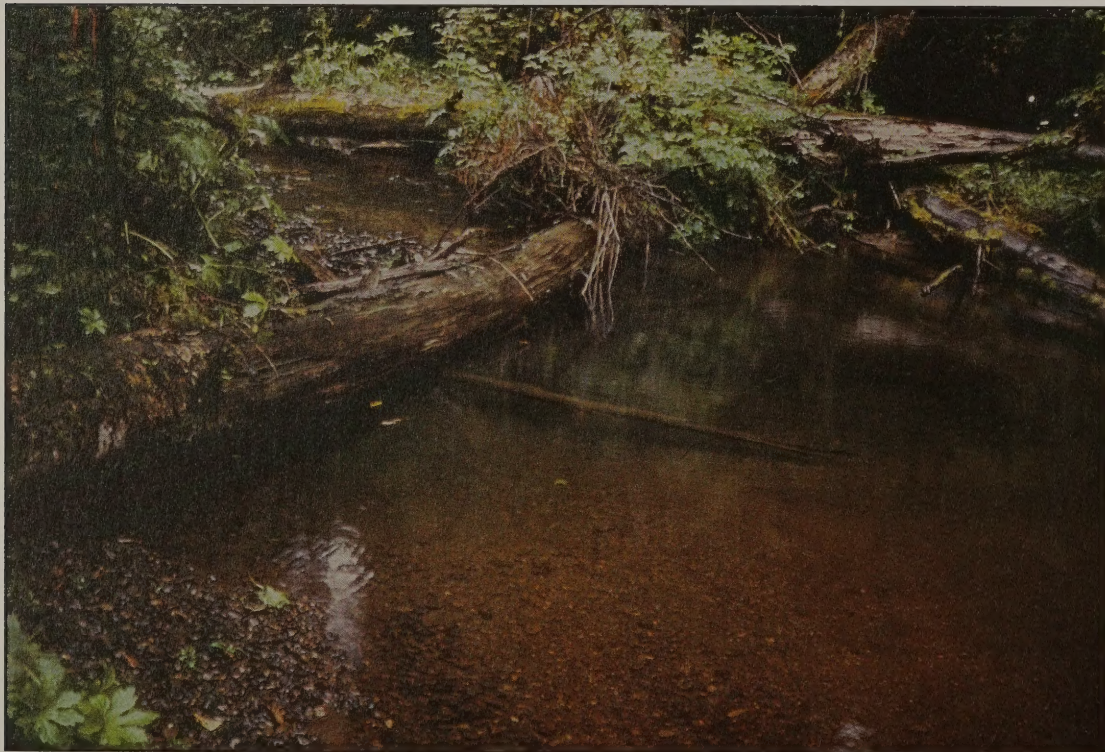
**Forested Coastal Stream—Oregon
Proper Functioning Condition**

The photograph to the left depicts a forested riparian-wetland area that achieved the rating of *PFC*. The photograph clearly shows a coastal stream that contains adequate vegetation and large woody debris that is dissipating stream energy associated with high waterflows, thereby reducing erosion and improving water quality. The plant community has developed root masses that have stabilized streambanks against cutting action, filtered sediment, and captured sufficient bedload. This has aided floodplain development and has improved flood-water retention and ground-water recharge. The natural process has created diverse ponding and channel characteristics that provide the habitat and the water depth, duration, and temperature necessary for fish production, waterfowl breeding, and other uses, thus supporting greater biodiversity.
